Closed Drain Line Repair Above Splash Zone

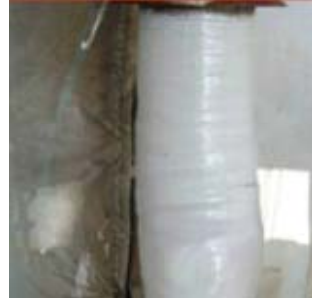
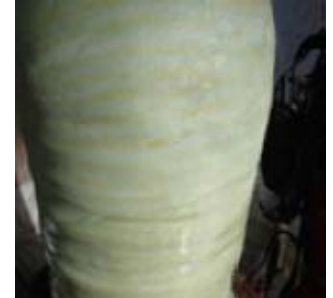
A closed drain system section within the splashzone area was identified as having suffered circumferential weld cracking, internal erosion and local wall thinning leading to a pinhole through-wall-defect. A temporary bandage repair had also been applied.

A Technowrap 2K™ repair would be installed repairing the defected area providing a design lifetime extension of 3 years. This 2K™ repair was also suitable for the assets design pressure of 11.34 Bar and design temperature of 38°C.

Using a custom built platform and habitat gave a degree of protection from the weather and from any stray waves rising higher than the platform floor. Rope access trained personnel applied the repair at height from a suspended platform at the required location.
