Glycol Tank Repair

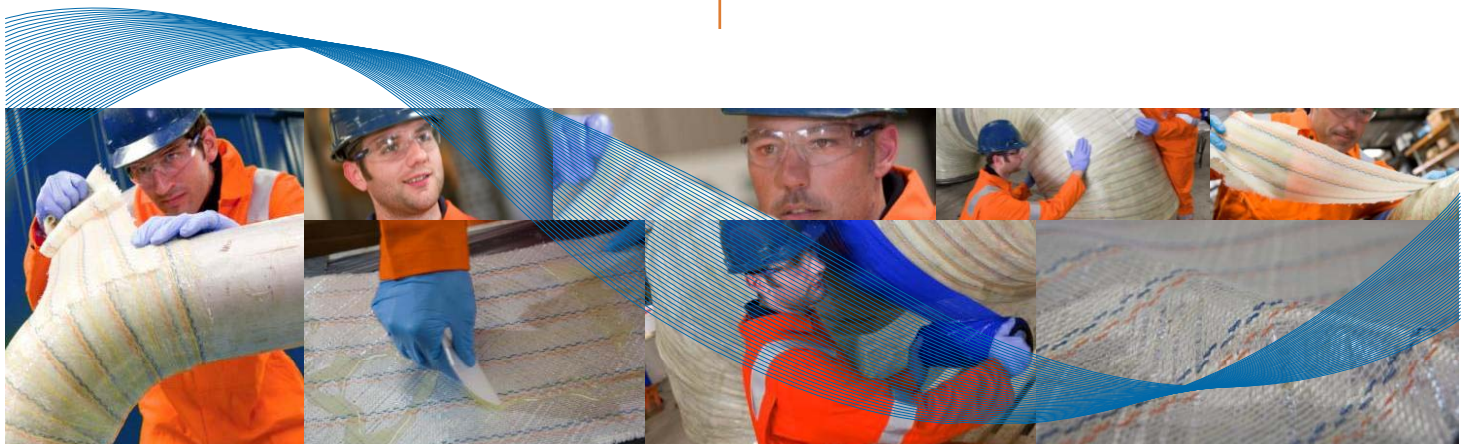
A glycol tank (part of the water injection pump skid) suffered a 4mm single fillet weld rupture due to high vibration levels on the skid. A repair was required.

Within this specific maintenance task it was evident the standard installation technique may fail to reach full compression prior to the curing stage. To remedy this, a new approach was taken in installing the standard Techowrap 2K™ system whilst vacuum bagging procedures were used to ensure full compression achievement prior cure.

Following repair installation with implementation of vacuum bagging techniques, the tank still had ongoing vibration. However it was still in service 12 months following the repair installation. At this time an opportune shut down period had still not yet occurred for the original planned tank change out.
