Wall Thinning and Pitting Flare Line Repair

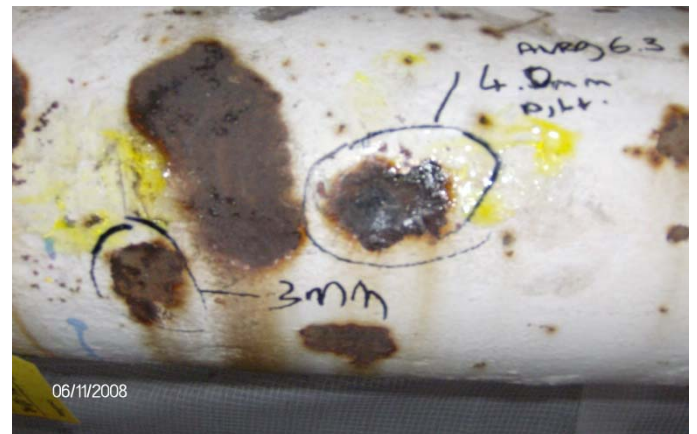
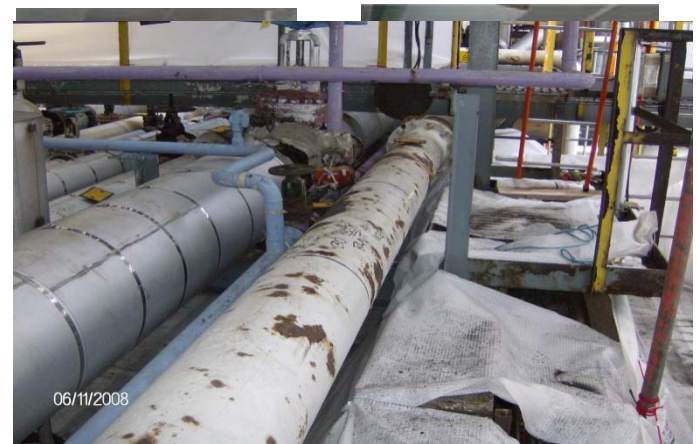
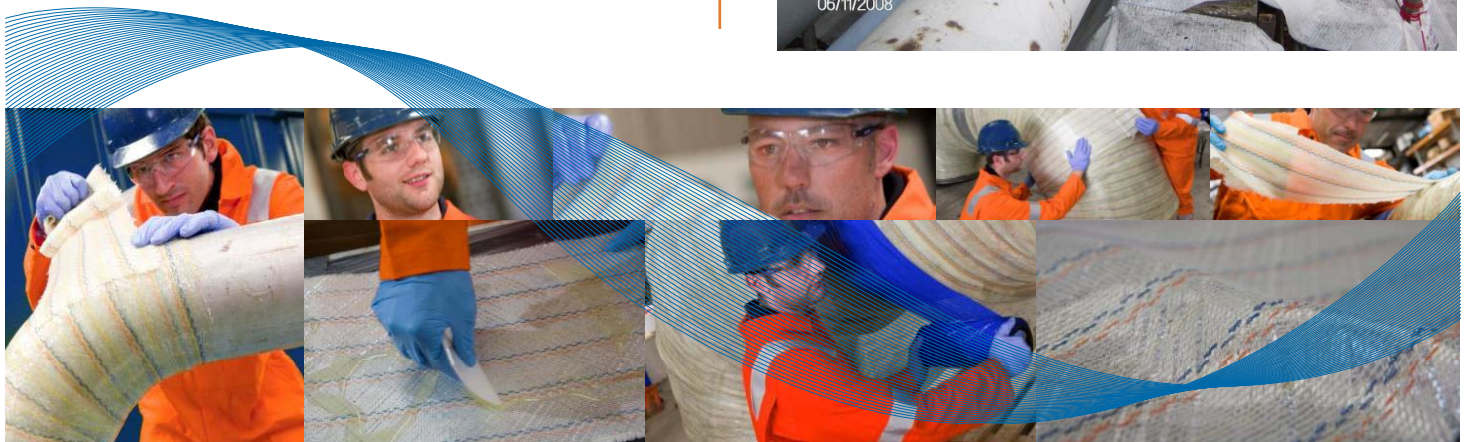
A 10" flare header line situated at a downstream oil refinery had sustained, within a 1 meter section, wall thinning and pitting defects due to external corrosion. Pit depths were measured at 4mm with the corresponding remaining wall thickness recorded as 2.3mm. The maintenance team had, prior to contacting Walker Technical Resources, shut down the line.

A Technowrap 2K™ repair was installed on the flare line following completion of the required surface preparation. Following repair implementation, the line, containing a light hydrocarbon fuel gas and operating at 70°C, was given a design life time extension of 20 years.
