Clamp Encapsulation Repair

Overview

A 16" flare line at a downstream oil refinery had sustained external, internal corrosion and through wall defects. Through wall defects were found in four locations along the 30 meter length of pipework. Temporary clamps had been applied on these four identified defected areas.

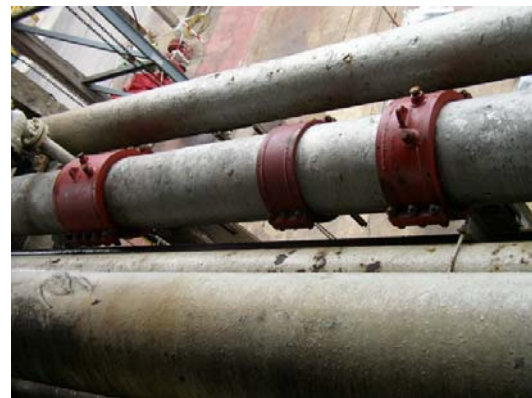
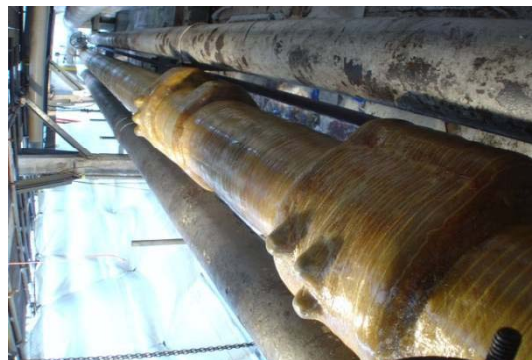
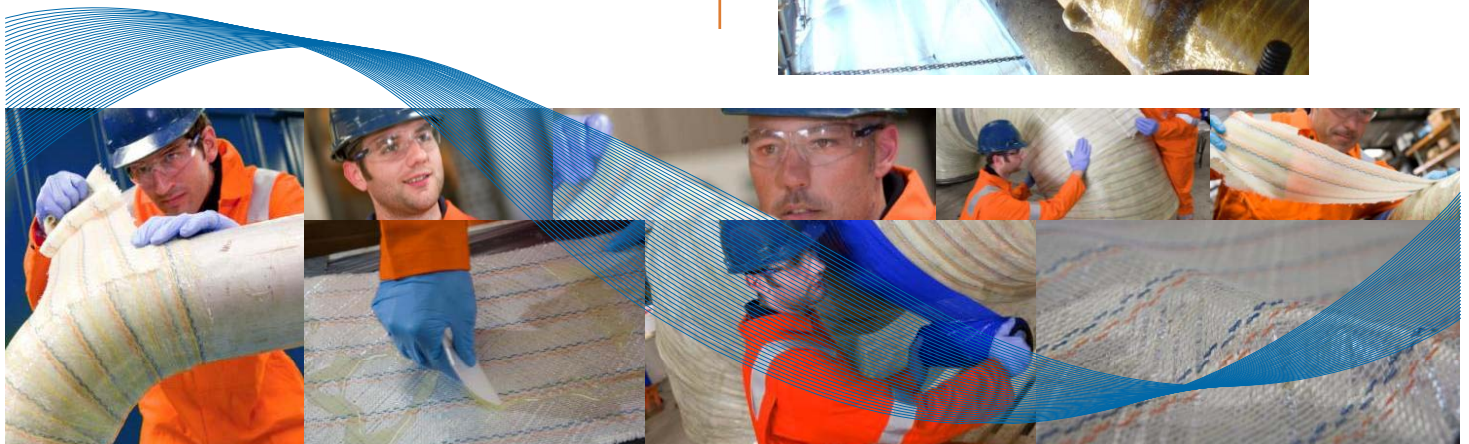
A Technowrap 2K HT™ repair was installed onto the Flare Line which included encapsulation of the clamps. The repair restored the structural and pressure integrity extending its lifetime for a further 4 years, as per Client requirements.
