## High Temperature Flare Line Repair

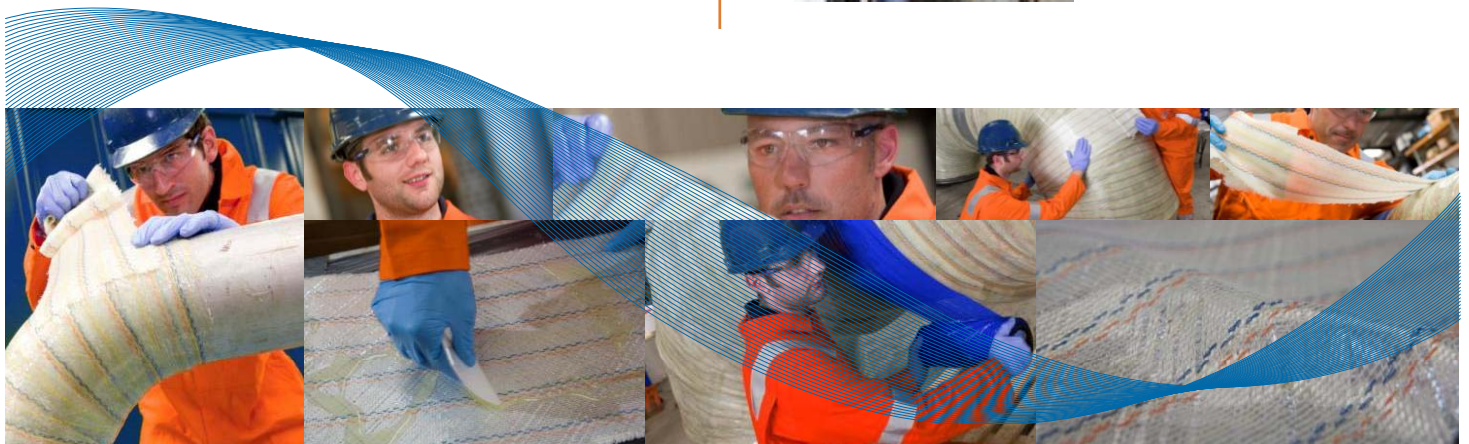
A high temperature flare line was suffering from a combination of external corrosion and internal erosion. The pipework contents also included high levels of H<sup>2</sup>S implying difficulty in maintaining safe access with potential of sour gas egress.

Because the composite repair was used to encapsulate clamps already being used as a temporary repair on the line, a design calculation was also required for each of these clamps, due to their additional weightings and the impact this would have within designing an overall successful, fit-for-purpose composite repair.

As per design calculations a repair was installed using Technowrap 2K H.T™, a high temperature system capable of installing a repair to this particular lines design operating temperature of 204°C. A post cure method was used with Barcol hardness checks to ensure the repair systems full cure.
