## Hydrocarbon Gas - Metering Skid Line Repair

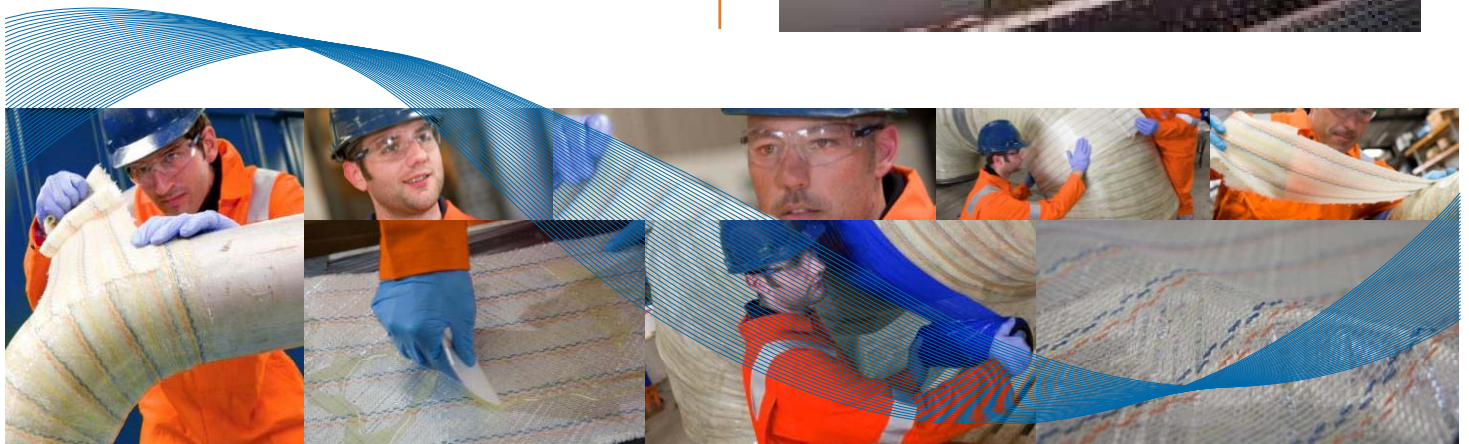
A major Metering Skid Line, with 17 platforms feeding into the system, was found to have Corrosion Under Insulation (CUI), and the Remaining Wall Thickness (RWT) was below 50% of the maximum allowable working pressure.

The line was a 16 x 8" branch section. Due to Stress loadings (axial loads and bending moments), stress analysis was required in the XYZ axis of the 8" branch. A design analysis was completed with recommendation to install the Technowrap 2K™ system whilst the line was 'live'.

The remaining wall thickness of the line was measured and risk assessment completed, to assign which surface preparation the steel would take. In this specific case, SA2½ was carried out. Due to this particular repair, emphasis of stress analysis data was crucial to the repair design.

A Walker Technical technician mobilised at short notice to begin the installation process and to provide total encapsulation of the line using the Techowrap 2K™ system. This design engineered repair extended the life time of this crucial line by a further 20 years. Post cure and barcol hardness checks were undertaken to ensure complete cure was achieved.
