Closed Drain Line Repair Above Splash Zone

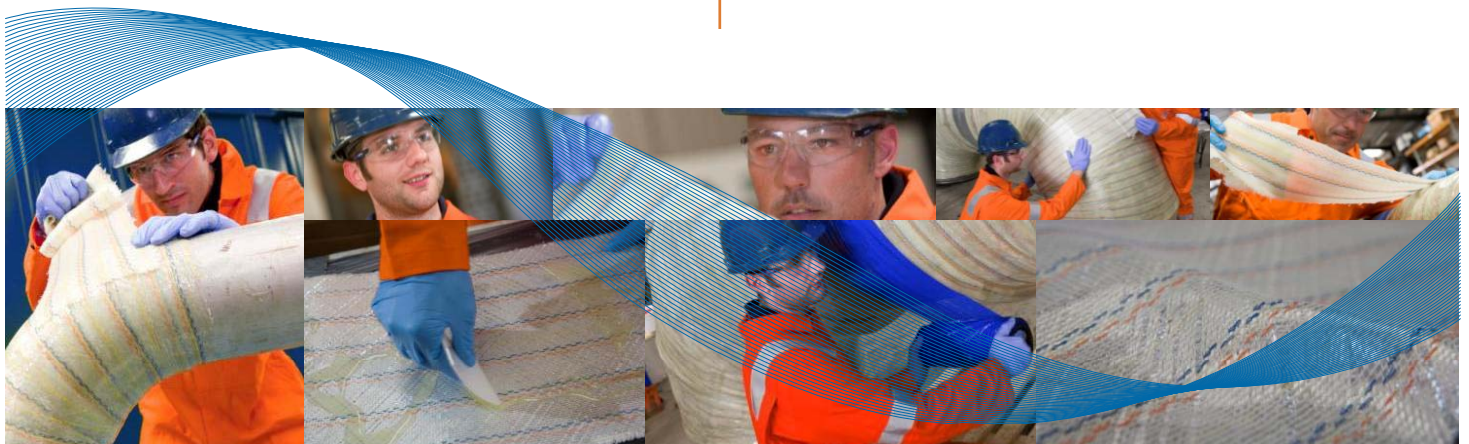
A closed drain system section within the splashzone area was identified as having suffered circumferential weld cracking, internal erosion and local wall thinning leading to a pinhole through-wall-defect. A temporary bandage repair had also been applied.

A Technowrap 2K™ repair would be installed repairing the defected area providing a design lifetime extension of 3 years. This 2K™ repair was also suitable for the assets design pressure of 11.34 Bar and design temperature of 38°C.

Using a custom built platform and habitat gave a degree of protection from the weather and from any stray waves rising higher than the platform floor. Rope access trained personnel applied the repair at height from a suspended platform at the required location.
